THESIS

**ANALYSIS OF UNDERBEAD CRACKING IN
UNDERWATER WET WELDMENTS ON A516 GRADE 70
STEEL**

Ryan D. Manning

September 1998

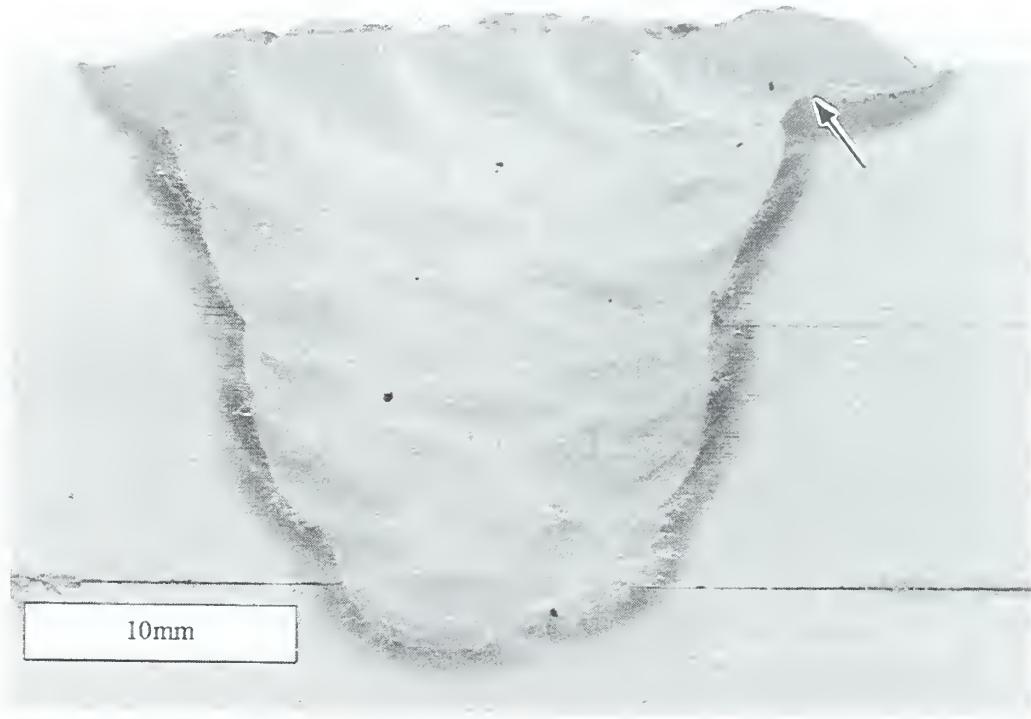
Figure 3.3 Macrophotograph of UWW12 weld sample – Underbead cracking is indicated by an arrow

The macroscopic photographs taken by GRM Photo, Inc. that appear as Figures 3.2 -3.4 show various features of the weld samples. At this magnification extensive cracking from the weld cap to the root is seen on the UWW05 sample whereas the cracks in the UWW12 and UWW25 are somewhat localized near the cap of the last weld pass and are much finer. The additional feature that can be seen because of the deep etching is the effects of the multipass weld as described by Lundin, et al., [Ref. 3] and seen in Figure 2.4. Bead tempering is evident in all of the passes except the last one. This suggests a reason why the cracks are likely to originate near the last weld pass because this area of the weld sample has the highest hardness which was confirmed by microhardness measurements.

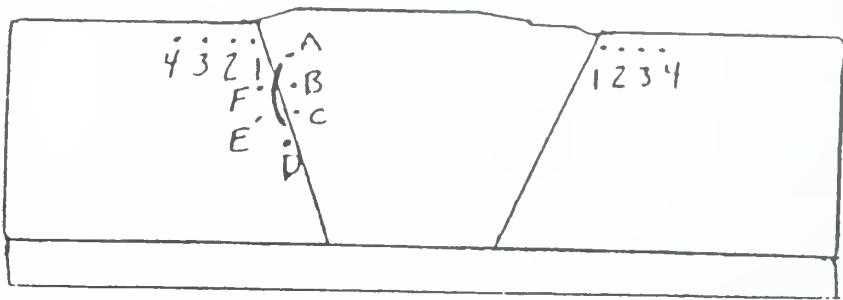
The microhardness measurements described in the experimental procedure section are listed in Table 4.4. Figure 4.4 shows the typical regions where microhardness measurements were taken. With an average hardness of 296-297 HV in the HAZ near the last pass weld cap area, this is an indication that the microstructure is martensite and bainite as was confirmed by optical microscopy. The average hardness around the cracks found near the last pass of the weld was between 360 and 366 HV. This indicates that the microstructure is nearly all martensite and explains the reason that cracking occurred in this hard and brittle section of the HAZ.

Figure 4.4 Typical regions where microhardness readings were taken

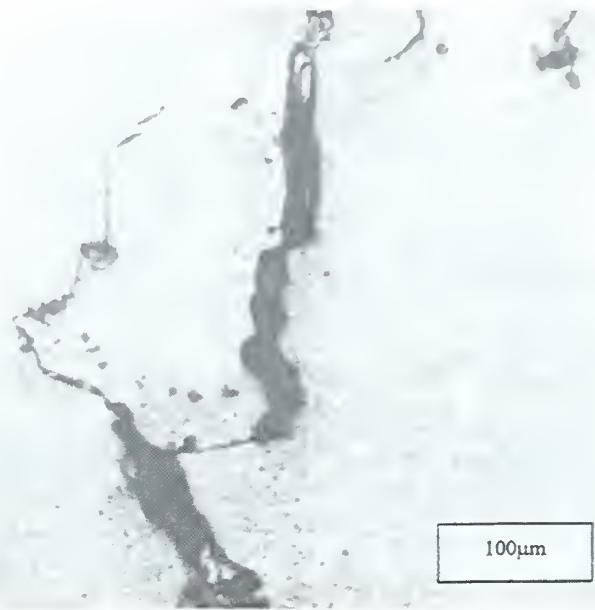
microstructure in which the cracks were found. The cracks nearly always were found in the coarse grain region of the HAZ near the fusion line. The cracks would eventually be arrested after branching into the base metal or into the fine grain region of the HAZ. The extensive crack branching found in UWW05 is shown in the micrographs in Figures 4.5 and 4.6. Note the microstructure in this region is essentially martensite and bainite. In addition, the microstructure of the weld metal was also analyzed to confirm the findings of Fox et al and Murray et al [Ref. 8, 9]. The weld metal microstructure was found to consist mostly of acicular ferrite with smaller amounts of Widmanstatten (side plate) ferrite, grain boundary ferrite, martensite and bainite.

Figure 4.5 Optical micrograph of UWW05 showing extensive crack branching

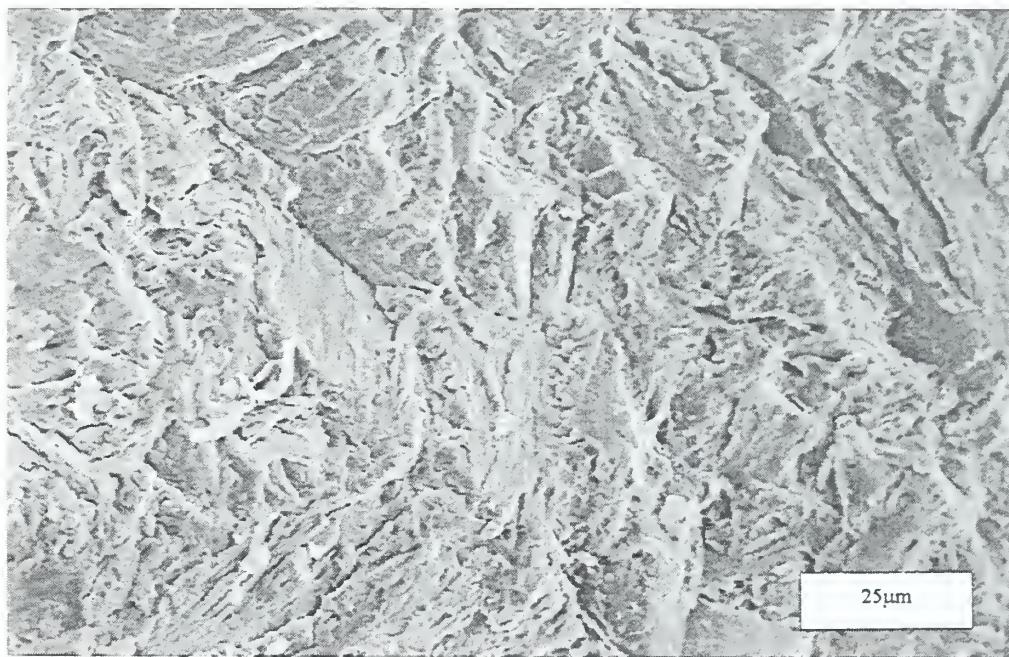
Underbead crack surfaces of UWW05 were examined in the S200 SEM to determine the mechanism of failure. Transgranular cracking and secondary cracking perpendicular to the fracture surface were clearly seen in this sample. Figure 4.7 is a micrograph which clearly shows these features which are typical of hydrogen assisted cracking.

Figure 4.7 SEM micrograph of transgranular cracking on the surface of the fracture with secondary cracking

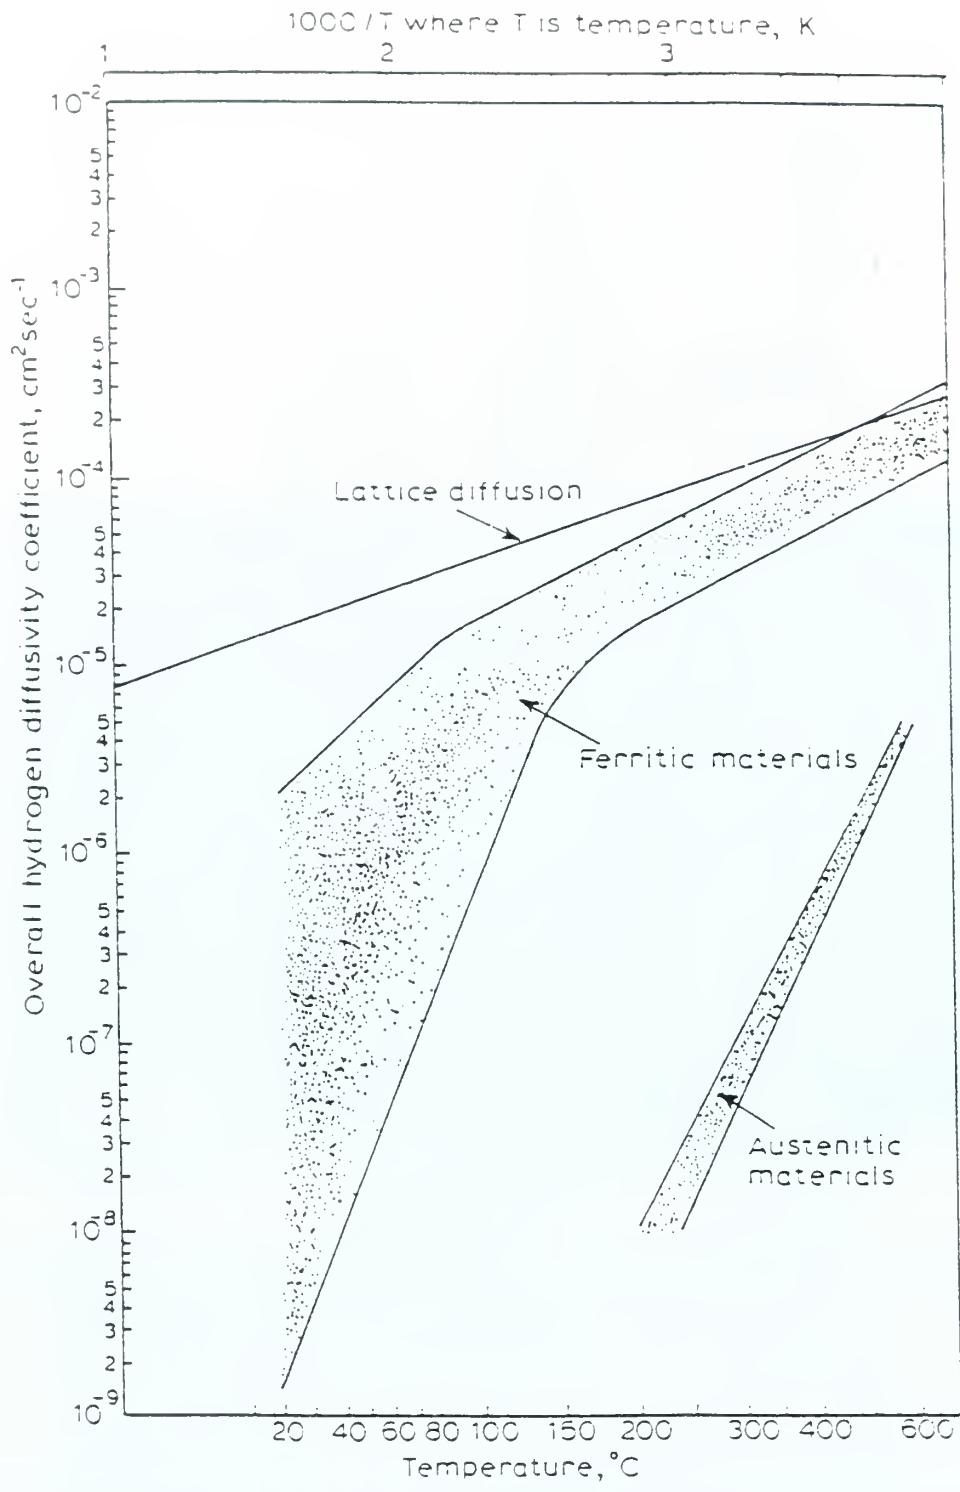
Figure 4.8 Variations in the measured diffusivities of hydrogen in ferritic and austenitic steels [Ref. 10]

[Ref. 10] for temperatures below 200°C. This is $D_o = 1.2 \times 10^{-3} \text{ cm}^2\text{s}^{-1}$ with an activation energy of $Q = 3.27 \times 10^4 \text{ Jmol}^{-1}$. Using these same constants the diffusivity of hydrogen in UWW05 = $8.55 \times 10^{-10} \text{ cm}^2\text{s}^{-1}$ and in UWW25, $D = 2.00 \times 10^{-9} \text{ cm}^2\text{s}^{-1}$. This results in a diffusivity of hydrogen that is 2.6 times slower in UWW05, which could explain the difference in underbead cracking. Figure 4.8 shows the variation in diffusivities of hydrogen with respect to temperature. As can be seen, there is a rapid decline of the diffusivity coefficient around 200°C in ferritic steels together with a large scatterband of values which no doubt arises because of the differing numbers of defects acting as sinks in the different samples studied. This explains our large difference in diffusivity of hydrogen between two temperatures that have such a small temperature differential. Easterling [Ref. 10] explains that this sudden drop is likely due to the increased amount of sinks found in the ferritic steel at temperatures less than 200°C such as inclusions, cracks, and other various defects.
